Manhole Inspection Summary

Manhole # S27A1_010MH

Location Address: **2132 ANNAPOLIS RD.**

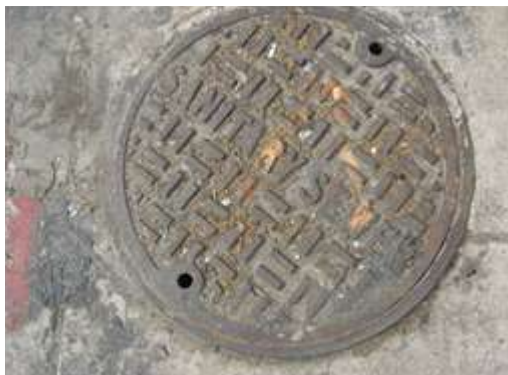
Cover View

Condition: **Sound**

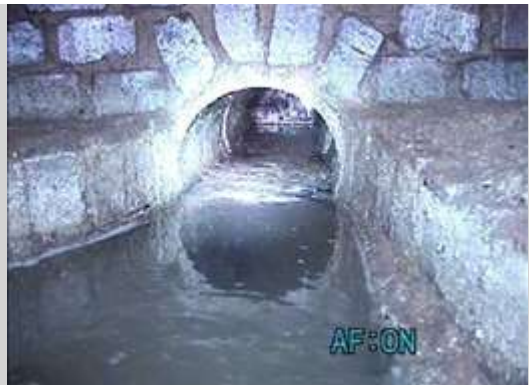
3 O'Clock Inflow

8 in. Circular Gravity Sewer
Pipe In @ 3 O'Clock

Pipe Height: **8.4** (in.) Rod and Bar (Angled)
Pipe Material: **Clay** ☐ Pipe Lined
Invert Depth: **12.89** (ft.) Flow Characteristics: **Slow**
Deposits: ☒ None ☐ Mud ☐ Gravy ☐ Debris ☐ Grease
Silt Depth: **0** (in.) Deposits Extent:
Infiltration: **None** Pipe Seal Cond: **Sound**
